The Chicago Green Bungalow Project

The Chicago bungalow has been around for a century. A Green Team is working to make sure these houses last for another hundred years.

by Paul Knight

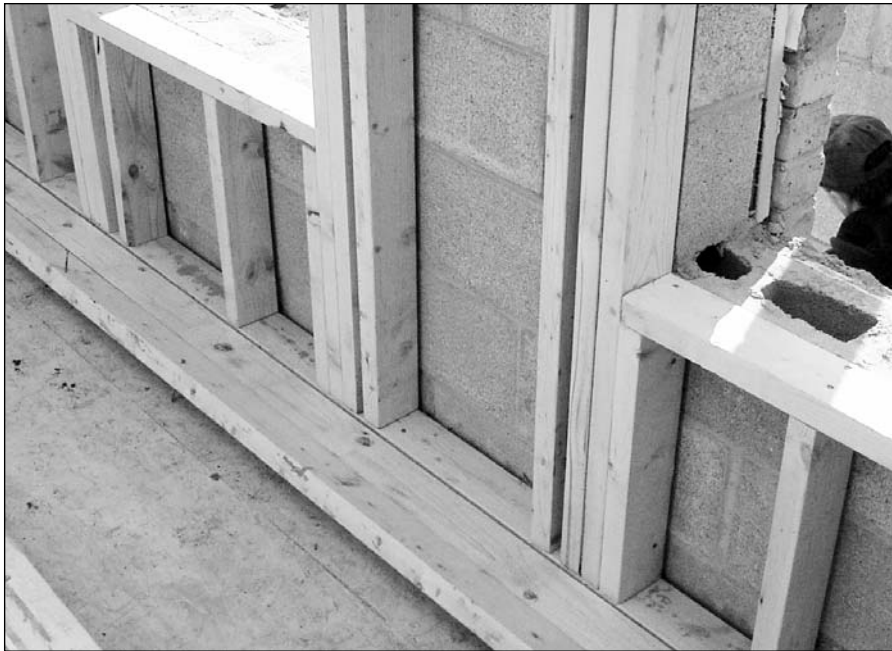
The rigid foam insulation between brick and block in this addition at 6423, combined with R-13 batts in the wood-framed interior walls, results in an R-18 wall.

block with interior 2 x 4 framing and R-13 batts);

- R-43 attic insulation;
- R-13 basement wall insulation;
- R-10 full slab-on-grade insulation;
- new double-glazed low-e windows with a U-value of 0.34 and an SHGC of 0.31 (old pulley wells were packed with insulation);
- air sealed bypasses and obvious penetrations;

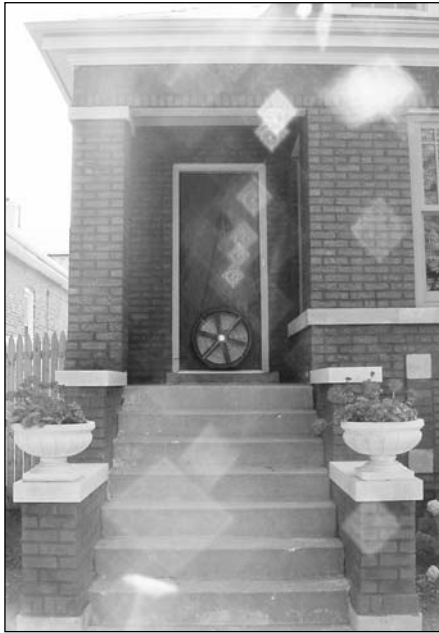
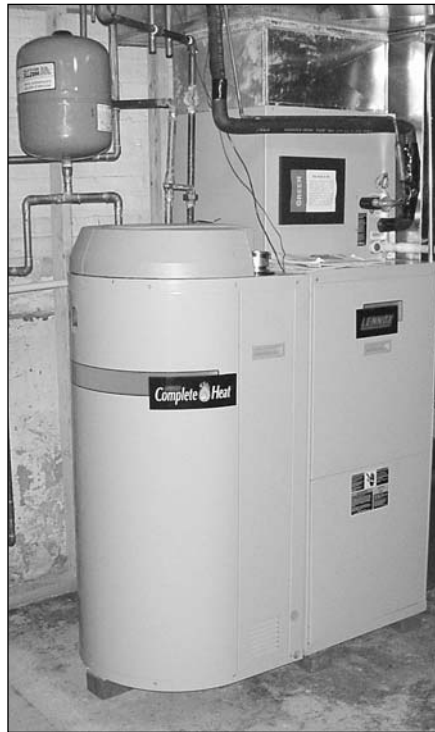
(left) The renovation at 6423 South Fairfield included the installation of a 90% efficient, direct-vent, sealed-combustion combination space- and water-heating furnace. (right) The renovation also included an addition that can serve as a home office. The walls of the addition include R-5 rigid foam between brick and block.

The interior of this home was in poor condition that warranted a gut rehab (see Table 2). Plaster and lath were removed from all the walls, exposing the interior studs and the masonry exterior walls. A 262 ft² space that can be used as a home office was added to the back of the home over a slab-on-grade. The home office area has a separate entrance and is connected to a kitchenette and bathroom in the
